**DEPARTMENT OF TRANSPORTATION**

Quality Assurance and Source Inspection

Contract #: 04-0120F4Cty: SF/ALA Rte: 80 PM: 13.2/13.9File #: 69.28**WELDING INSPECTION REPORT****Resident Engineer:**Pursell, Gary**Address:** 333 Burma Road**City:** Oakland, CA 94607**Report No:** WIR-014274**Date Inspected:** 01-May-2010**Project Name:** SAS Superstructure**OSM Arrival Time:** 700**Prime Contractor:** American Bridge/Fluor Enterprises, a JV**OSM Departure Time:** 1900**Contractor:** Zhenhua Port Machinery Company, Ltd (ZPMC), Changxing Island **Location:** Shanghai, China**CWI Name:** Wu Chi Cheng**CWI Present:** Yes No**Inspected CWI report:** Yes No N/A**Rod Oven in Use:** Yes No N/A**Electrode to specification:** Yes No N/A**Weld Procedures Followed:** Yes No N/A**Qualified Welders:** Yes No N/A**Verified Joint Fit-up:** Yes No N/A**Approved Drawings:** Yes No N/A**Approved WPS:** Yes No N/A**Delayed / Cancelled:** Yes No N/A**Bridge No:** 34-0006**Component:** Orthotropic Box Girder( OBG)**Summary of Items Observed:**

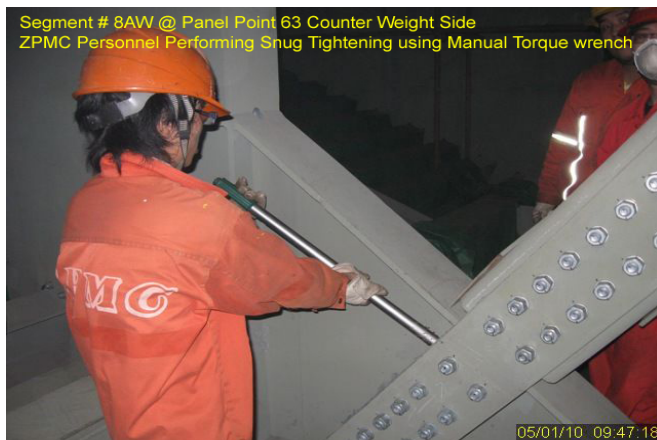
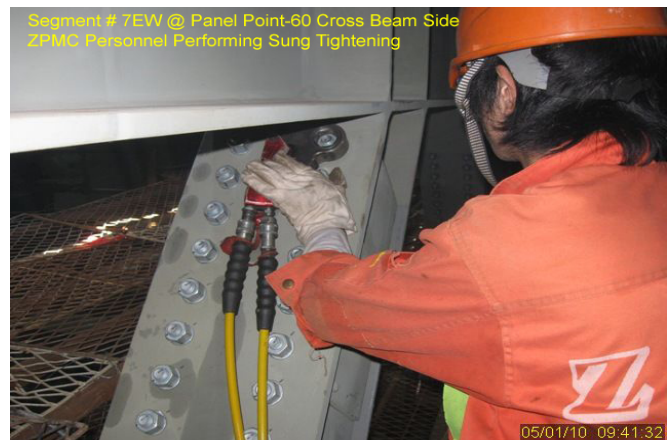
This Quality Assurance (QA) Inspector witnessed final tension verification for Lower Chevron X3D Angle and Lower & Upper Chevron Bracing (Cross Beam and Counter Weight side) at Panel Point (PP) 59 ~PP64 for Segment 7EW ~8AW. Inspected 10% on a random basis and found the tension to be in general compliance. Inspection was performed against the Notification No. 00338 Dated May 01, 2010.

Bolt sizes used were M22 x 65 RC Set# DHGM220021 and final torque required was Rotation of Nut.

Bolt sizes used were M22 x 70 RC Set# DHGM220017 and final torque required was 520 N-m.

Bolt sizes used were M22 x 75 RC Set# DHGM220034 and final torque required was 453 N-m.

Bolt sizes used were M22 x 80 RC Set# DHGM220029 and final torque required was 447 N-m.

Manual Torque wrench was been used with Sr. No. XQ2-779.

Note: Please refer the picture for more comprehensive details.
